# Barnes Lake Structure Inspection Report

Section 21, T.9N. – R.10E.  
Deerfield Township, Lapeer County, Michigan  
Located on Tributary to the North Branch of the Flint River

**Date of Inspection:** October 27, 2025  
**Date of Final Report:** November 5, 2025

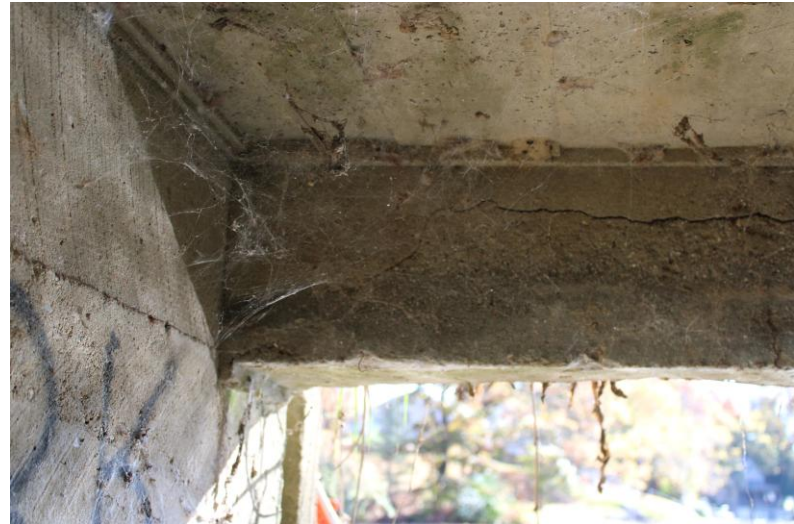
1. The concrete on the upstream portion of the box culvert has spalling and some cracks.  
Photos 2, 3

2. Spalling and cracked concrete along headwall of structure

**Recommend:** Monitor the spalling and cracks annually, by taking pictures to have a long-term photographic record of the spalling and cracks. Ask the County Road Commission to send an engineer to assess the concrete of the structure. Show them pictures from previous inspection reports. This will provide a better understanding of the conditions for future action plan.

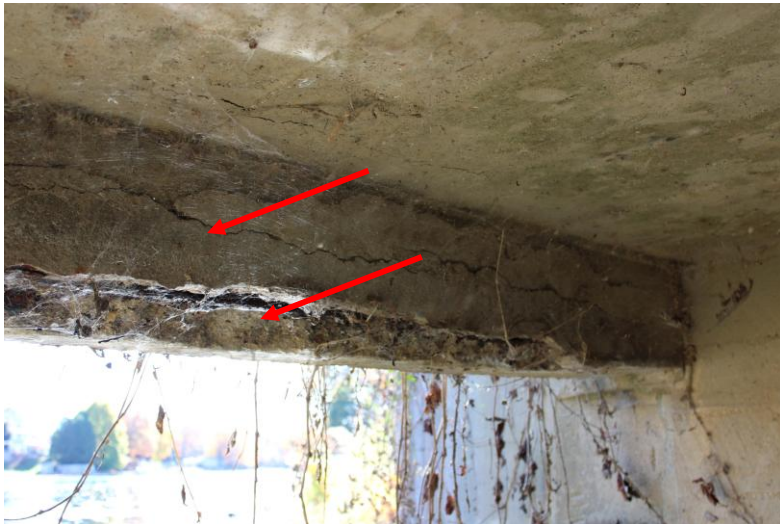
- B. The wood used as the stoplogs in the weir are eroding along their exposed grain lines. Photo 20.
- C. The concrete of the former bridge structure has some spalling, exposed re-rod, and cracks on the upstream face. Photo 3

3. Spalling, cracked concrete and exposed re-rod along structure. When compared to pictures from the 2020 inspection, not much change.

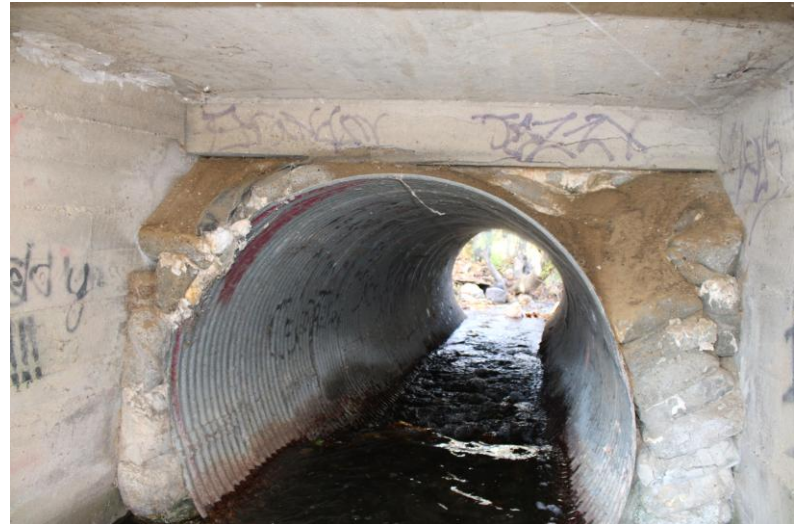
4. Connection point between the concrete box culvert and the CMP pipe. Photos 4 - 8

- D. There is some deterioration at the connection between the concrete structure and the 72-inch CMP which needs to be monitored. Photos 4, 5, 6, 7, 8,

4. Where concrete structure connects to corrugated metal pipe (CMP) in structure

**Recommend:** Monitor this connecting point annually. See above for the comment on a road commission inspection.

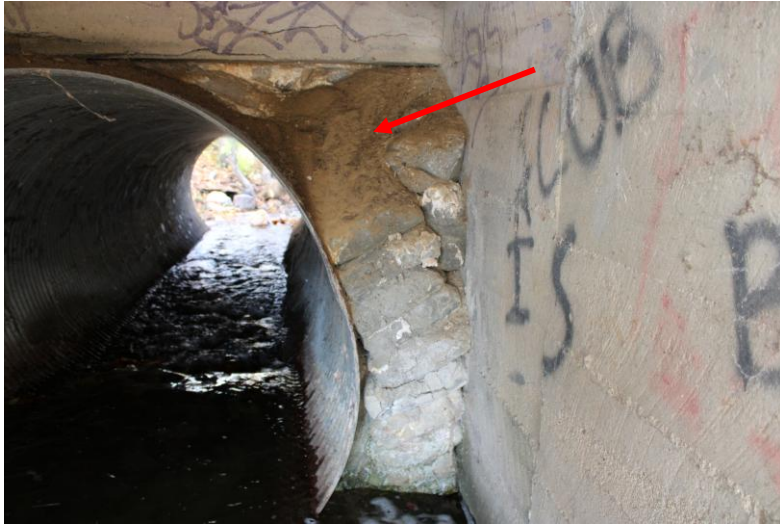
5. Right side of attachment note sediment spilling down headwall bags.

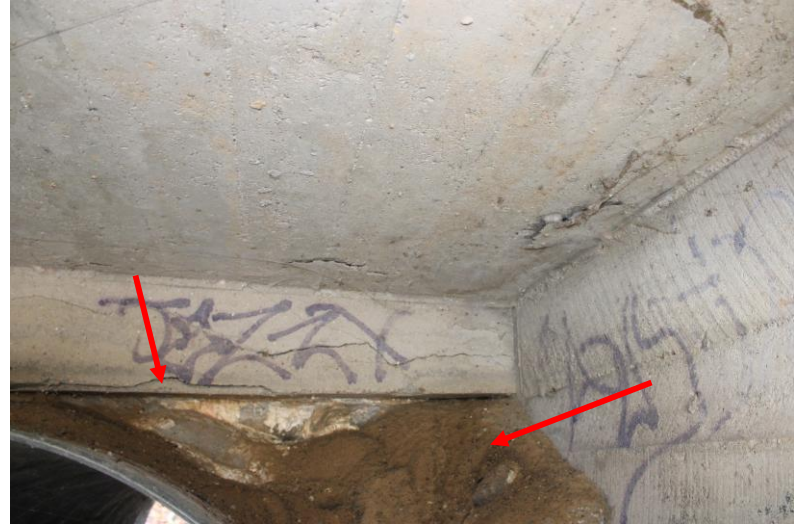
6. Cracking and sedimentation on right side of CMP

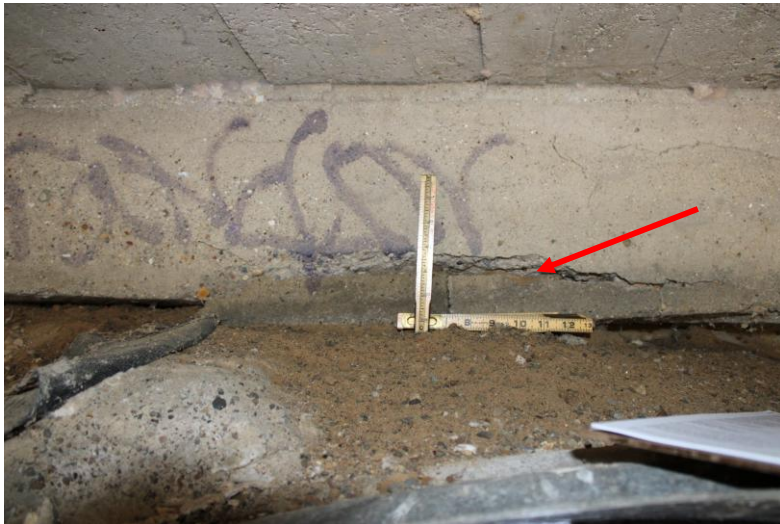
7. Crack in concrete on top of CMP

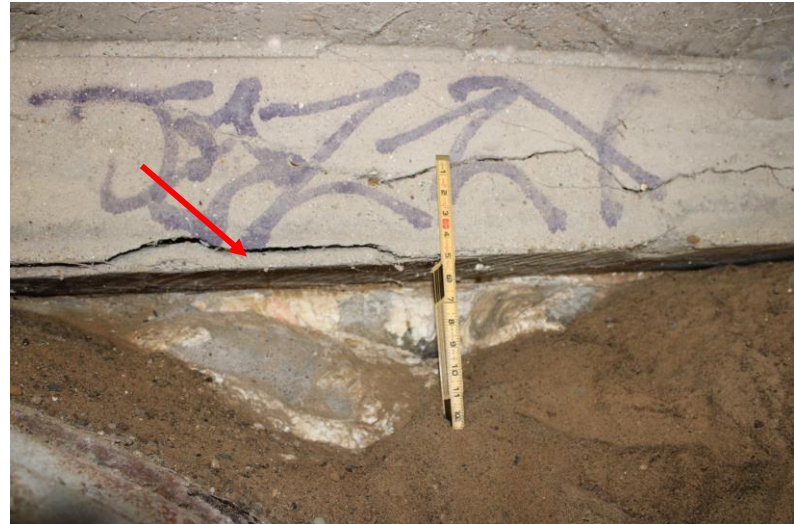
8. Crack in concrete towards right side of CMP. Compare with 2020 pictures

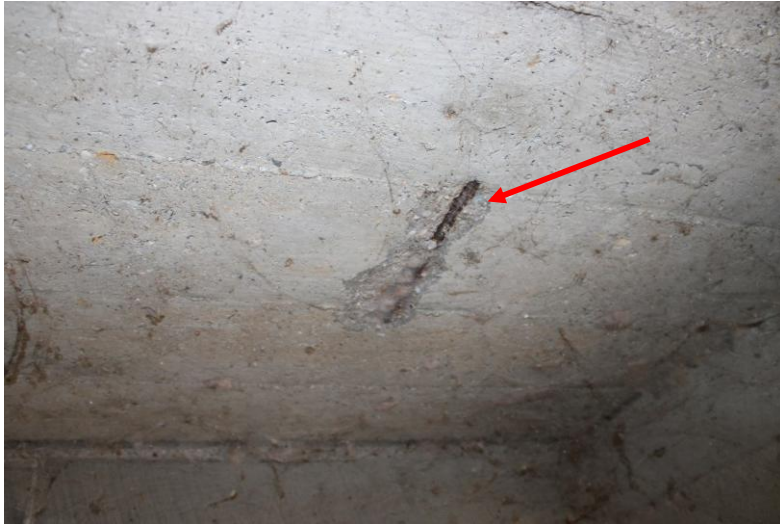
9. Exposed rerod in concrete box culvert about 3-ft inside of the structure

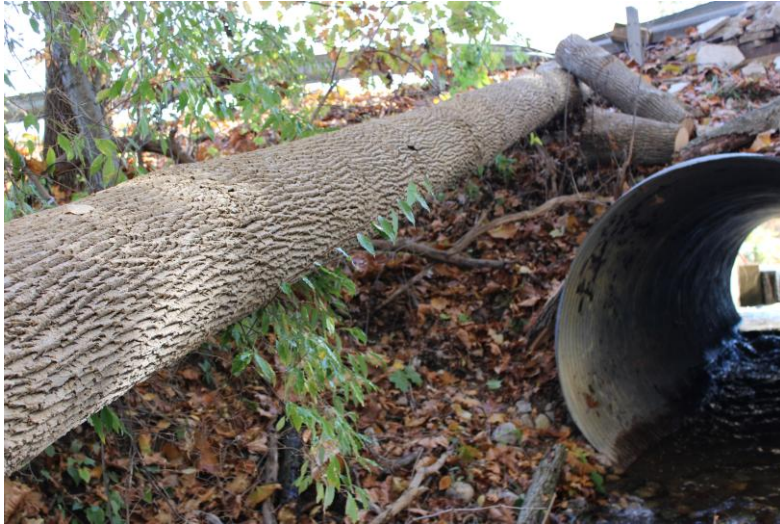
5. There is a large dead ash tree which has fallen diagonally across the stream just downstream from the culvert outlet. Photo 13

- F. There is a dead ash tree diagonally across the stream downstream of the culvert outlet. Photo 13
- G. The outlet pipe appears to be in satisfactory condition with minor corrosion along the flowline.

13. Dead ash tree diagonal across outlet stream.

**Recommend:** Removal of the tree and leave the roots (if possible) to ensure the bank on the west side does not erode badly.

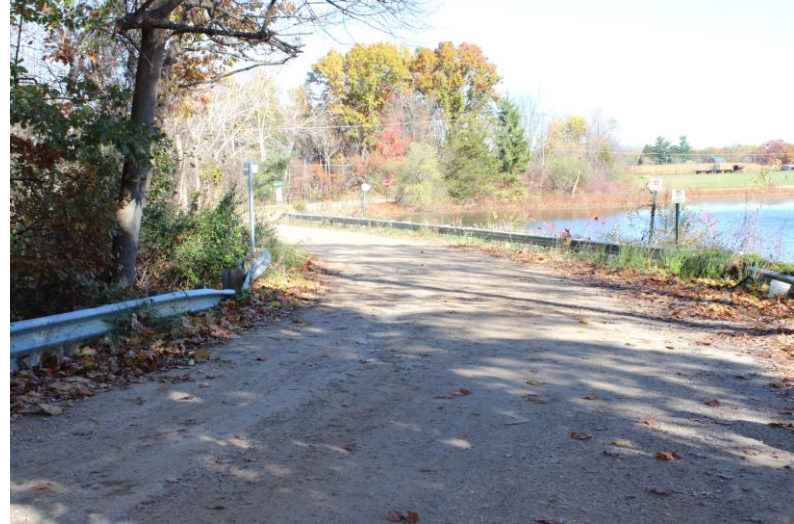
- 
7. There appears to be erosion along the right center of the road as one faces towards Barnes Lake Road. A plan should be developed to determine how to protect the road and shoulders of the road from erosive flows coming from upgrade areas of the roadway. Photos 14, 15

14. Road surface looking northward. Note erosion left of middle of road.

**Recommend:** Consider asking the Road Commission to review this site for erosion control and flow direction capture.

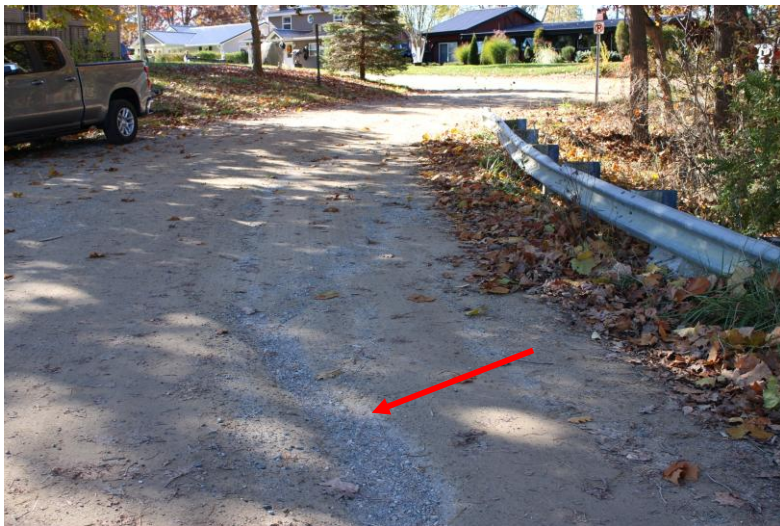
15. Gully erosion in road surface from previous runoff events.

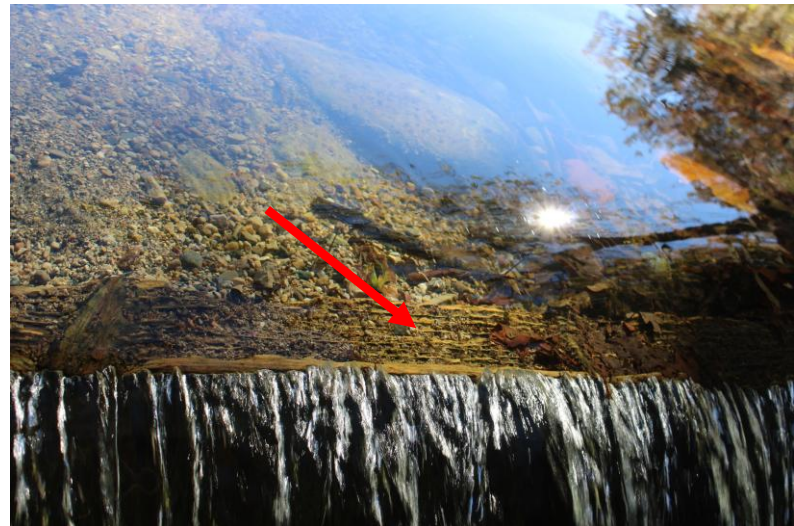
20. View of top weir stoplog showing the erosion of the wood grain.

| a.) Wood | Plan should be made to replace stoplogs in the next 5 years | 1 |

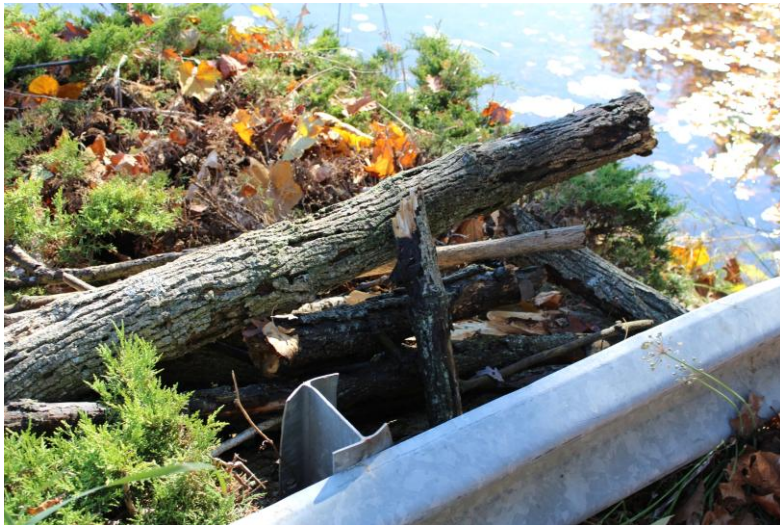
21. Woody debris removed before arrival of inspector.

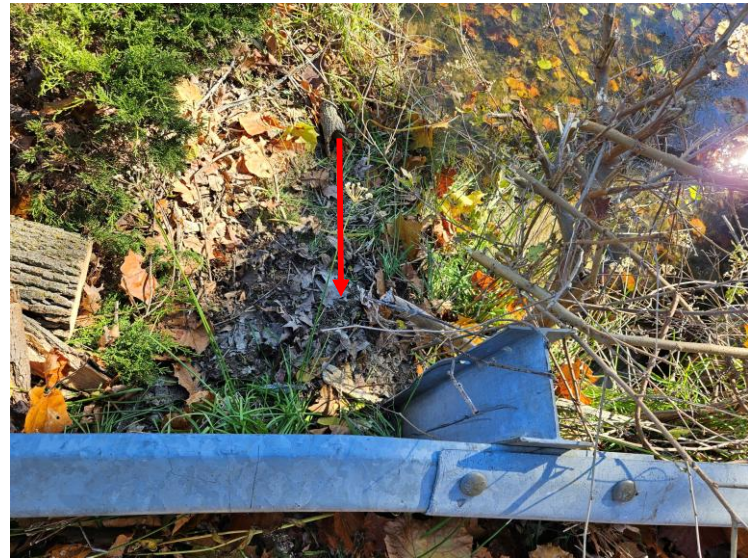
| c.) ditches | In 2020 noted 2 CMP tubes by structure on NE side which were plugged with debris, Could not see these tubes during this visit. | 7 |

22. There were 2 small diameter CMPs here during the 2020 inspection, not visible now during this inspection. See 2020 report for picture comparison.
